GEO | MORPHIX

Geomorphology
Earth Science
Observations

Project Code/Phase: PN 16107

Rapid Geomorphic Assessment

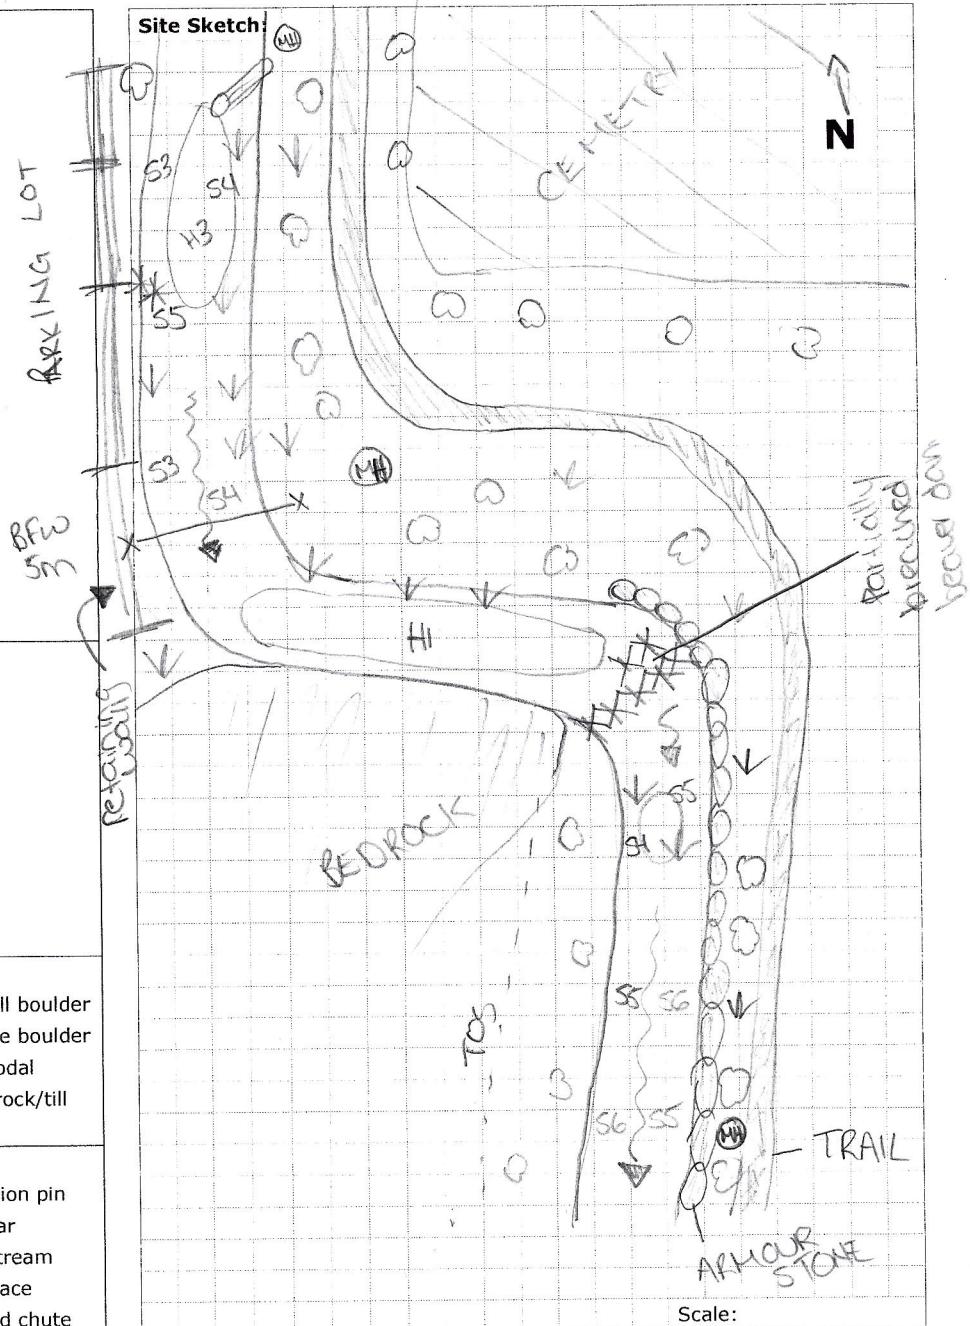
MH - manhole.

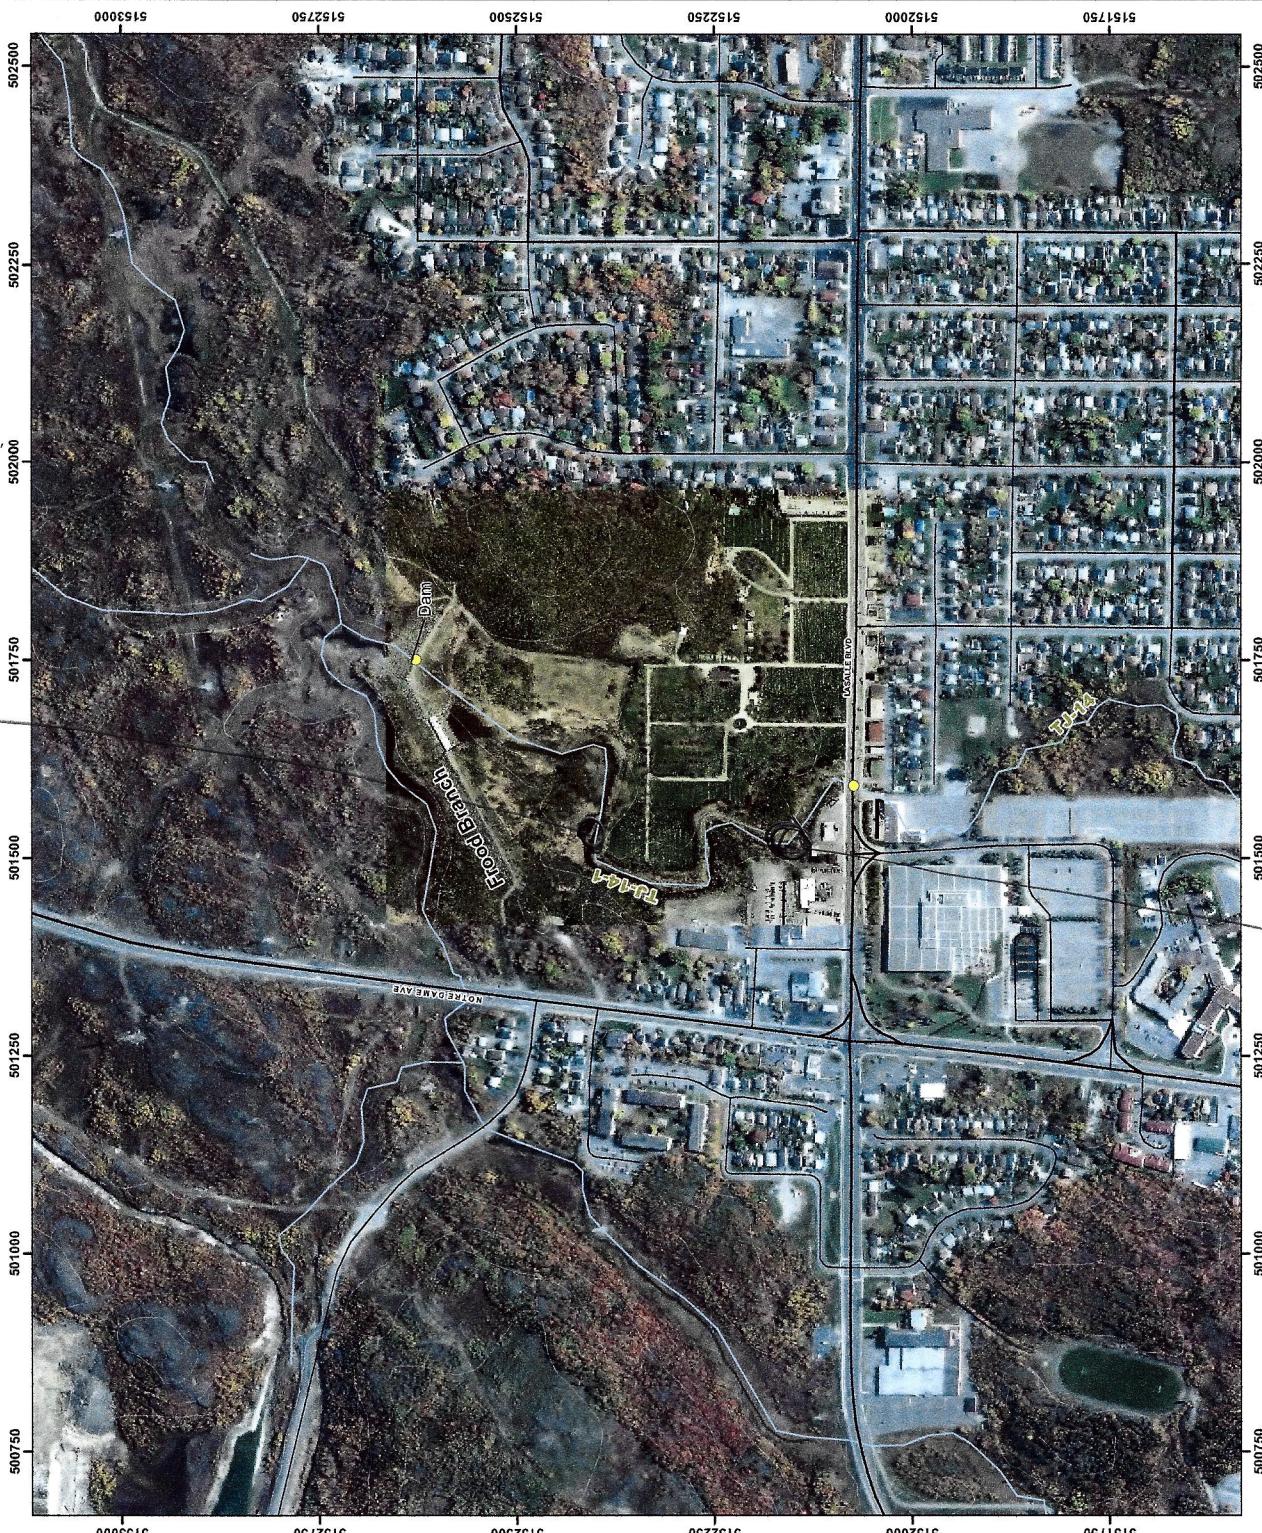
3 distinct sections of creek

Start - Lasalle →
